Improving Water Quality in an Urban Watershed

Washington Stormwater Conference
November 6, 2014

Lorna Mauren, P.E.
City of Tacoma
Environmental Services Department

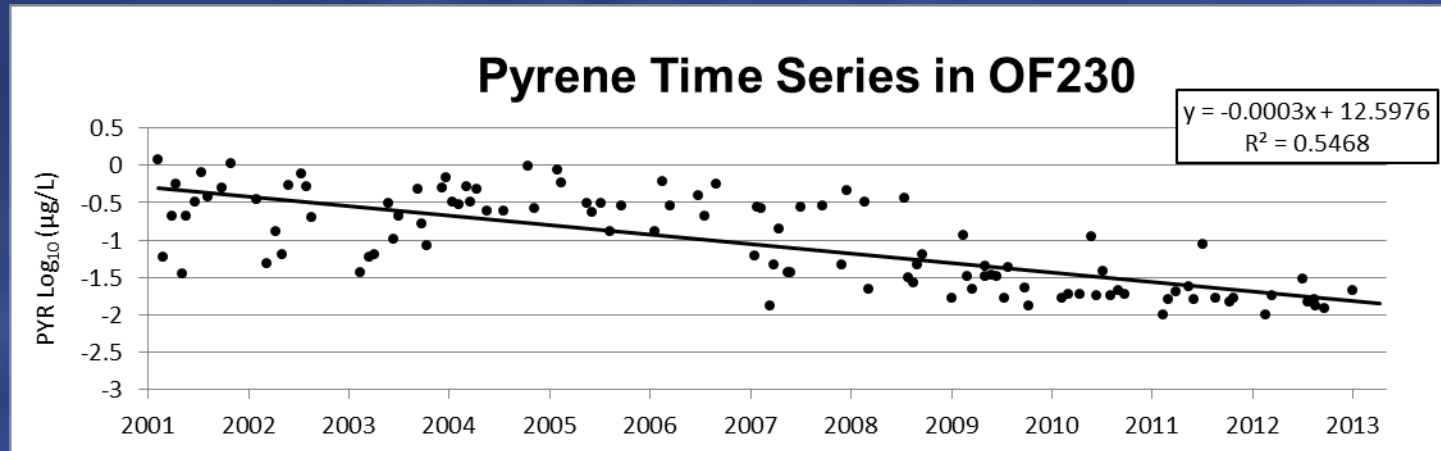
97% Reduction,
>99.9% Confidence

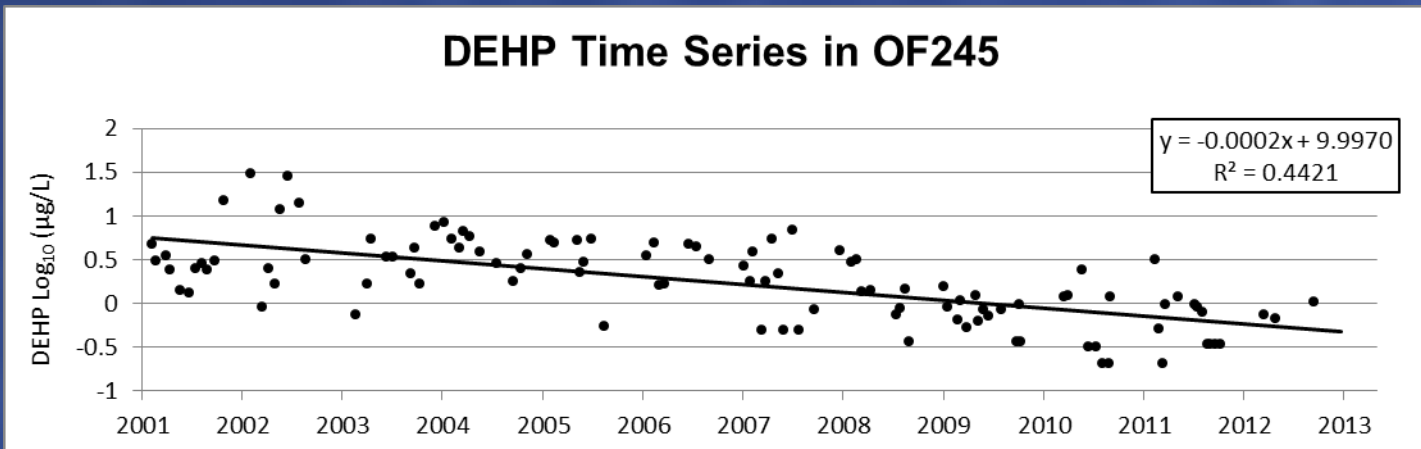
DEHP Time Series in OF245

92% Reduction,
>99.9% Confidence

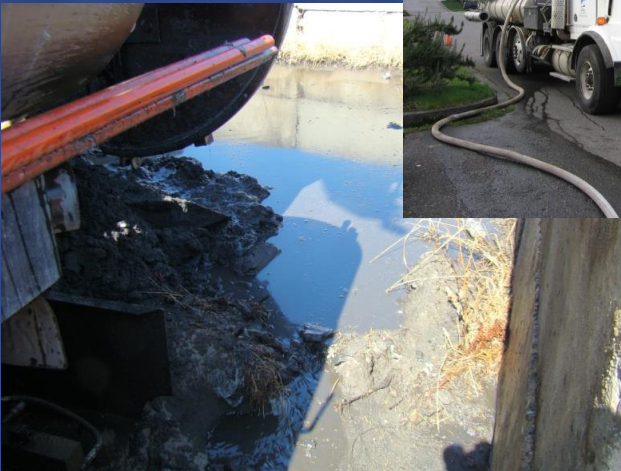
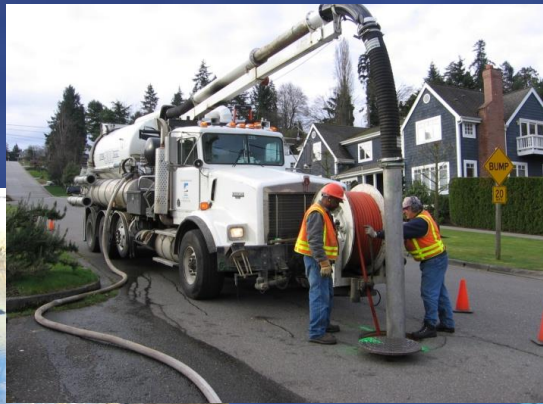
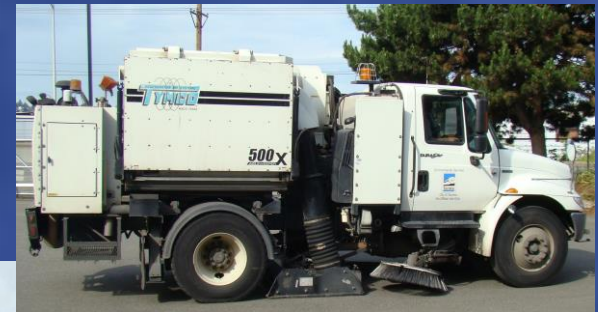
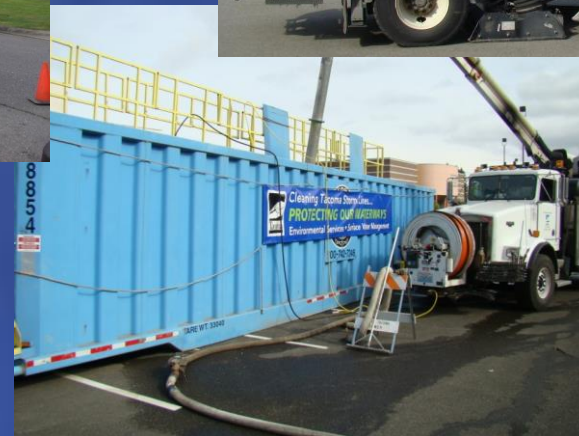
Enhanced Maintenance

1. Scrub the storm system to remove chronic contaminants
 - \$375,000/year
 - 75 tons removed
 - 28 miles/year
 - \$13,000/mile of pipe

2. Remove more sediment from our streets. Avg. data per sweeper.
 - \$150,000/year
 - 850 tons removed
 - 15,000 miles/year
 - \$35/mile of road

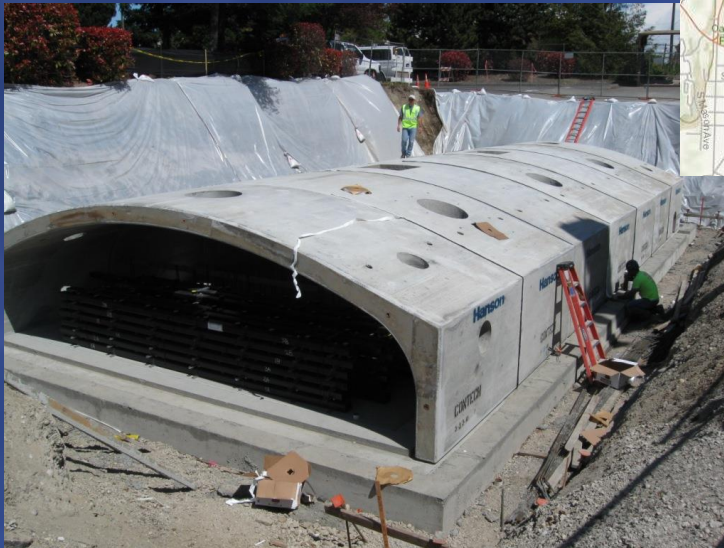
Treatment Retrofit - 2010

In spite of source control, identification and removal of a leaking fuel line and system cleaning... one area was still high in PAHs.

- \$1 million construction cost
- \$30,000 / year maintenance
- Treats 50 acres

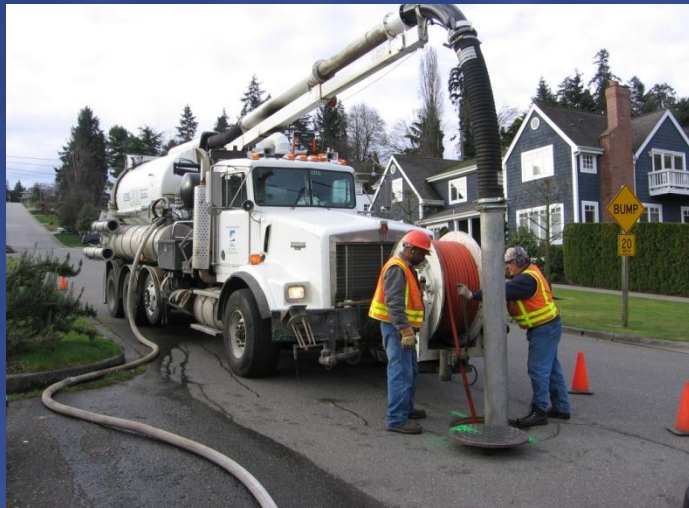
Pipe Cleaning Project –

- \$300,000 (2007)
- 150,000 feet cleaned
- Improves 600 acres
- Continuing to monitor to determine return interval

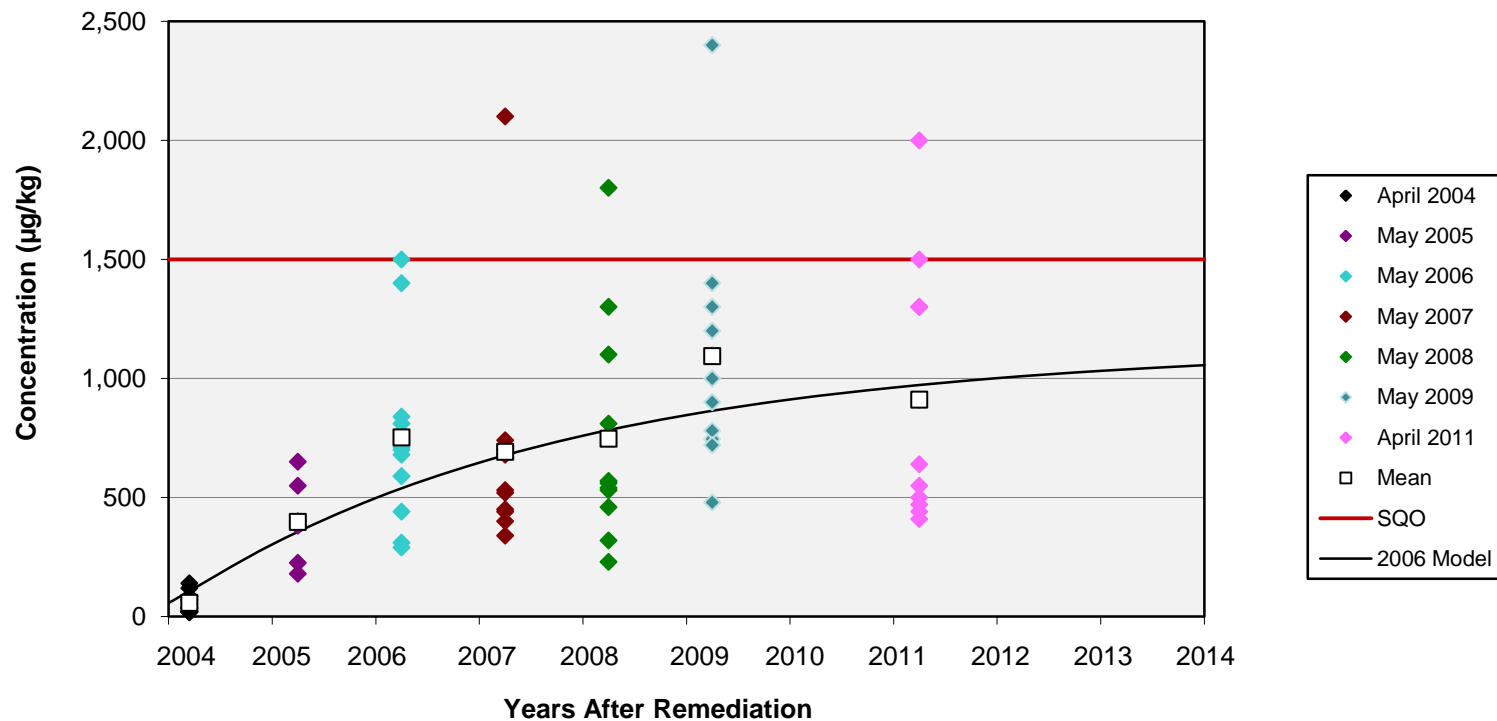
In-Waterway Sampling: Post Cleanup

Polyaromatic Hydrocarbon (PAH)

Phenanthrene

- Increasing number of downward trends and improving stormwater water quality!
- In general, waterway sediments are remaining below sediment quality objectives (SQOs).
- Phthalates generally exceed SQOs, but were projected to do so. This legal substance is common to urban landscapes.
- Continue to watch one sediment trend at head of waterway.
- Continue to implement workplan based on in-pipe sediment sampling, but the list is shrinking.

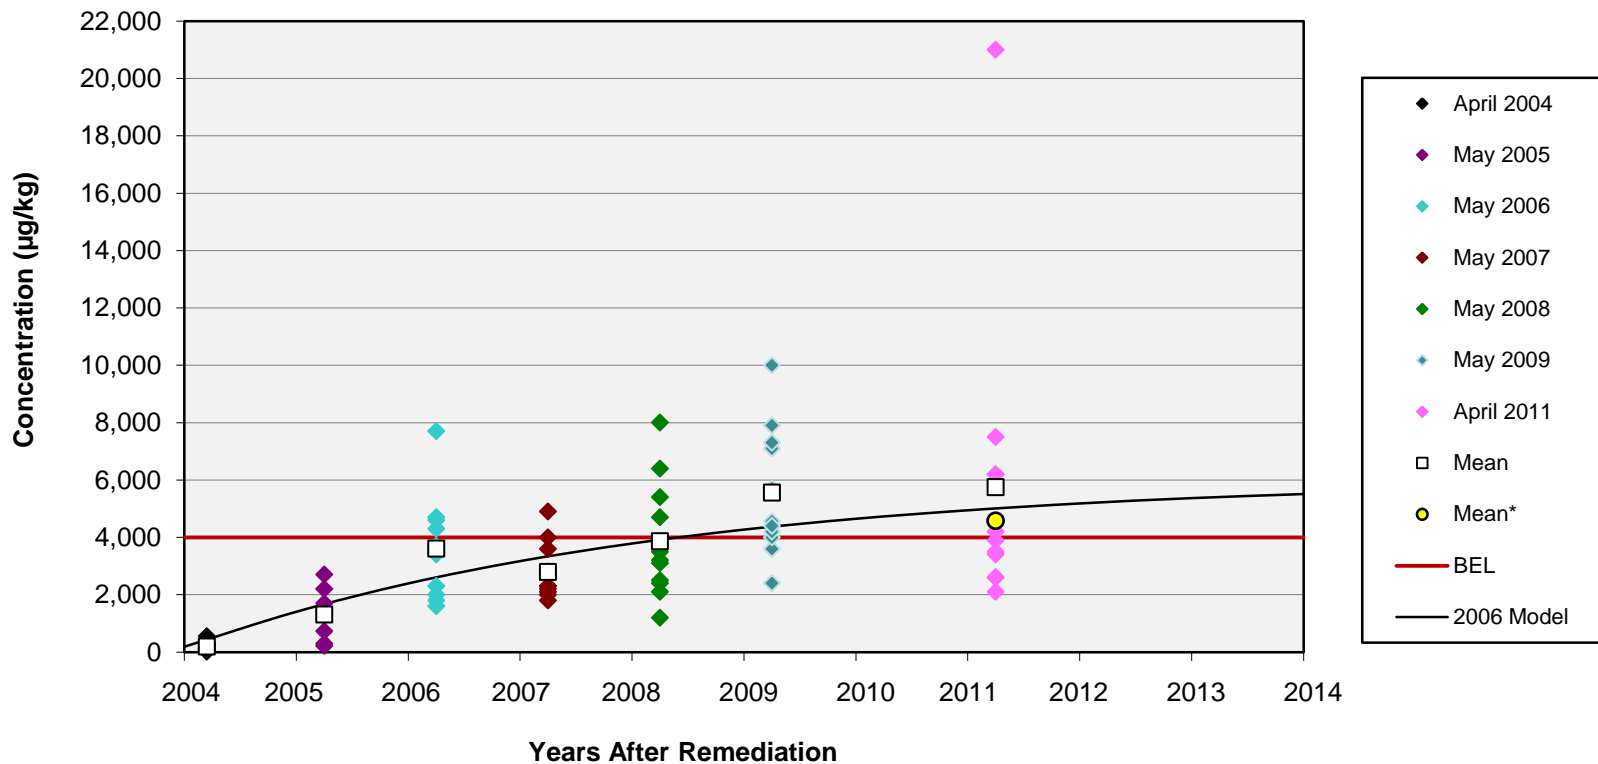
In-Waterway Sampling: Post Cleanup Phthalates

Bis(2-ethylhexyl)phthalate

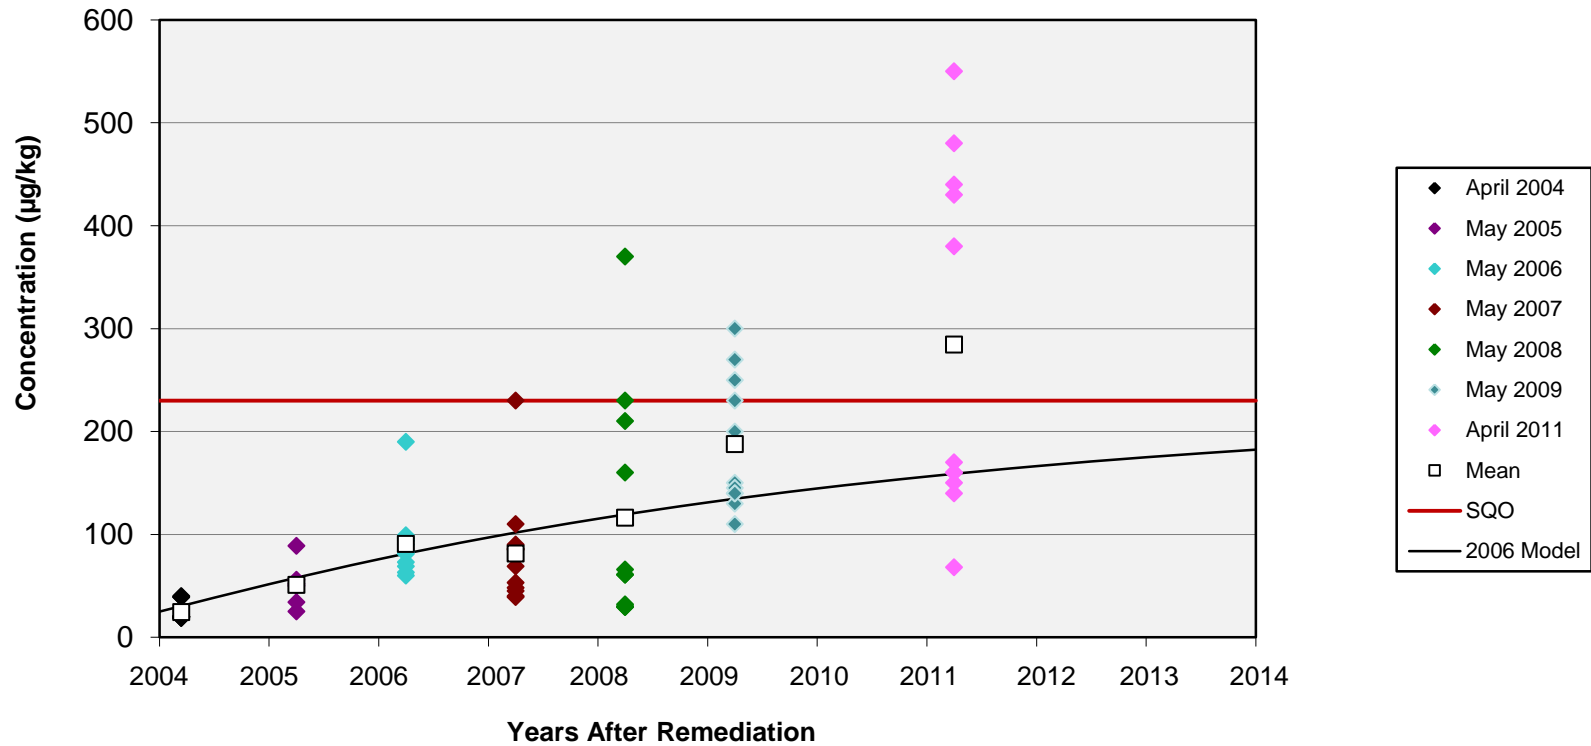
In-Waterway Sampling: Post Cleanup

Dibenzo(a,h)anthracene (PAH)
