OYSTER SHELL STORMWATER TREATMENT SYSTEM

OYSTER SHELL TREATMENT – DOWNSPOUT BARRELS

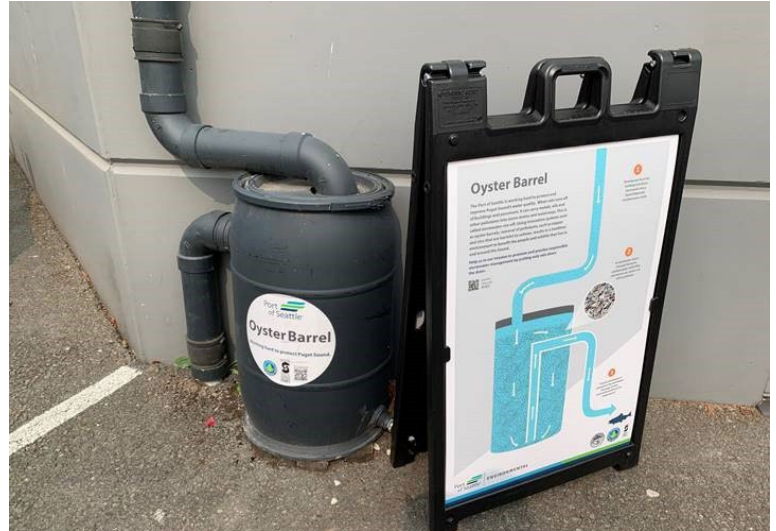
Figure 1. Oyster shell downspout barrel system and information sign at Terminal 102

In 2017 during a re-roofing project at Terminal 102, the Port constructed and installed 20 oyster shell barrels (see Figures 1 and 2) on drainage downspouts to treat approximately 2-million gallons of roof run-off a year. The treatment action of oyster shells is attributed to the structure, which filters solids, and calcium content, which promotes adsorption of metals from stormwater.

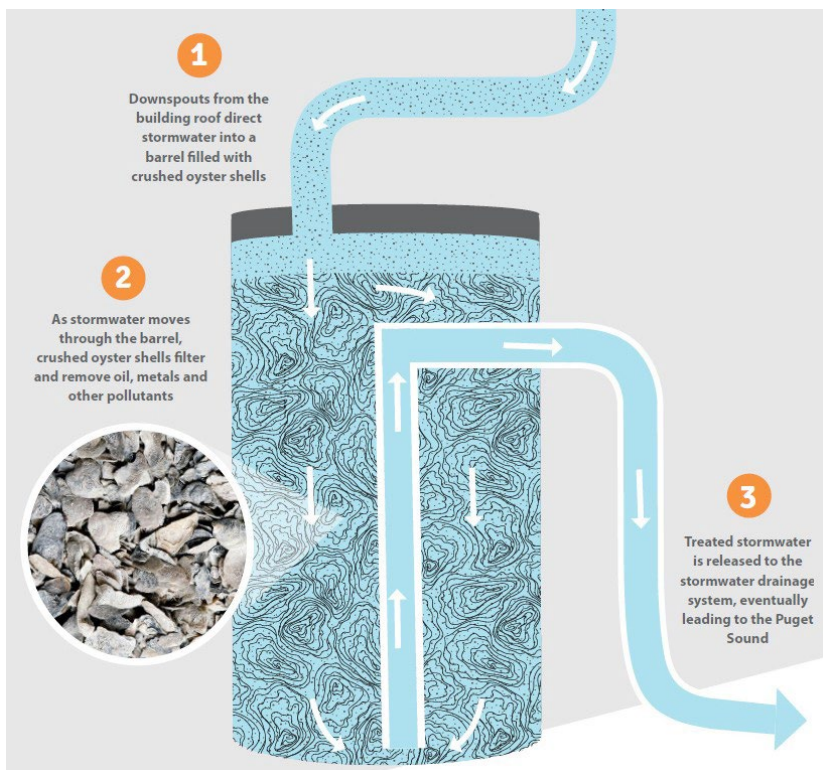
Figure 2. Information sign for oyster shell downspout barrels at Terminal 102

Each oyster shell treatment system has an inlet pipe that connects to the roof downspout, an outlet pipe that extends from the barrel bottom to about one-third from the top, and a pipe that connects to the stormwater system (Figure 2). The stormwater runoff from 88,000 square feet of roof area seeps through 25 to 30 gallons of crushed oyster shells to the bottom of the barrel, and then flows up the outlet pipe and into the stormwater system. Each of the 20 oyster barrels treat an average of 100,000 gallons of roof runoff each year.

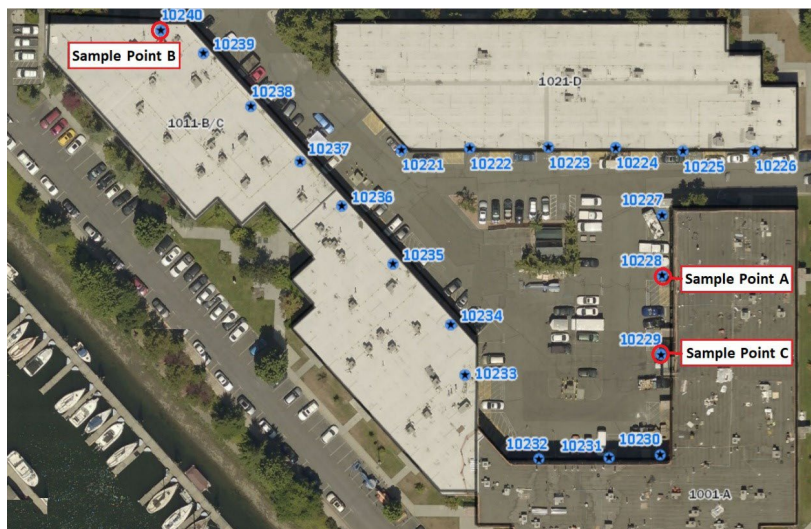
Figure 3. Oyster barrel locations at Terminal 102 displaying the three sample locations (numbered stars are downspouts)

To determine the effectiveness of this stormwater treatment, water quality monitoring is conducted and has been ongoing since the barrels were first installed in 2017. Two barrels were selected for sampling [Points A and B (Figure 3)] to represent effectiveness of the treatment system.

In September 2020, we began washing and reusing oyster shells using a media washing machine developed to remove sediment and ‘refresh’ the shells. To evaluate effectiveness of this effort, a new sampling point was added (Point C). The shells used in the Point C barrel are new oyster shells (i.e., have not been used for treatment prior to being put in barrels). The shells used in the barrels monitored as Points A and B, and all other barrels, have been refreshed. Monitoring data from this effort suggests that new shells perform better at reducing pollutants, showing a 14% higher average reduction of copper and zinc compared with reused shells. Monitoring will continue to determine if and when the reused oyster shells should be replaced due to loss of effectiveness.

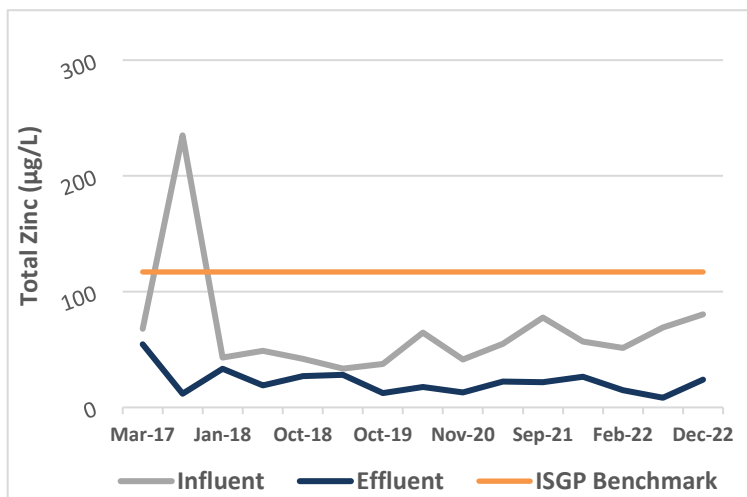
Figure 4. Average zinc concentration in roof runoff before treatment (influent) and after treatment (effluent) at Terminal 102 between March 2017 and December 2022

Stormwater treatment effectiveness is determined by analyzing stormwater collected before (influent) and after (effluent) flowing through the oyster shell barrels. As shown in Figures 4 and 5, testing results spanning 15 sampling events, dating back to 2017, show that oyster shell treatment significantly reduces pollutants from roof runoff, with effectiveness for zinc in the range of 57%, copper in the range of 48%, and 34% for turbidity.

Over time, the effectiveness of the oyster shells to reduce pollutants decreases and they must be replaced or refreshed by washing. Through stormwater monitoring data, we have found that the treatment systems are effective for approximately one year. After one year, effectiveness of the system appears to decrease and metal concentrations in effluent increase.

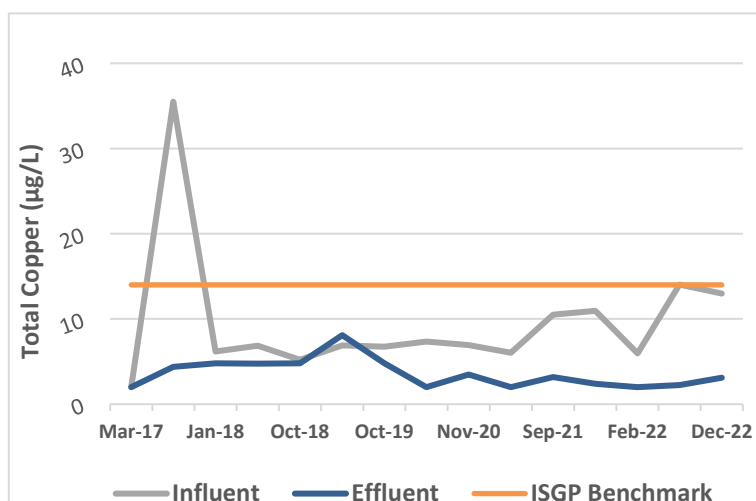
Figure 5. Average copper concentration in roof runoff before treatment (influent) and after treatment (effluent) at Terminal 102 between March 2017 and December 2022
